Restoration

Matthijs Musson (Antwerp, 1598 –1678/79)

Jesus in the House of Martha and Mary
ca.1640-1650
oil on canvas
230 x 340 cm
inv. no. 2565

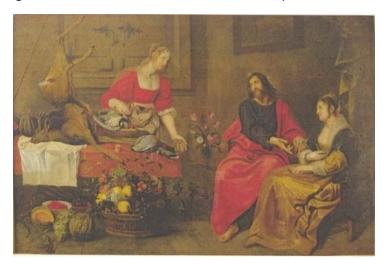
In 1980, when the work entered the BBVA Collection, its appearance was quite different to its current state, especially in the top right, as previous repaintings had modified some elements of the composition.

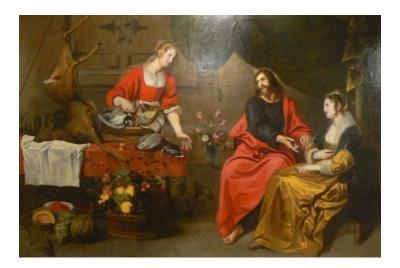
In 2004, the repainting of part of the window frame, the back wall and the picture on it was removed, but not the cloth that is hanging on the wall behind Mary. The underlying original hanging drapes and tassel in the central part were in good condition though quite modified in the part just above Jesus and Mary.

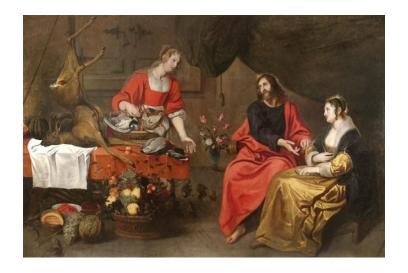
In 2012, in view of the insensitive interventions made over the course of time, it was decided to undertake an in-depth restoration of the work in order to return it to its original condition. The Artistic Heritage Department commissioned a battery of organoleptic tests, which included exhaustive photographic documentation, preparation of detailed drawings and maps of alterations, taking samples and evaluating them in the laboratory and a study with UV and IR light, afterwhich an intervention strategy was drawn up for each one of the different elements and phases.
